155 Robbins Road

HISTORIC RESOURCES INVENTORY
BUILDING AND STRUCTURES
 HIST-6 NEW 5/77

IDENTIFICATION	
1. BUILDING NAME (Common)	(Historic) Seth Stanley House
2. TOWN CITY	VILLAGE COUNTY
Berlin	Kensington Hartford
3. STREET AND NUMBER (and/or location)	8-4 14-2/54/41
155 Robbins Road

Seth Stanley House

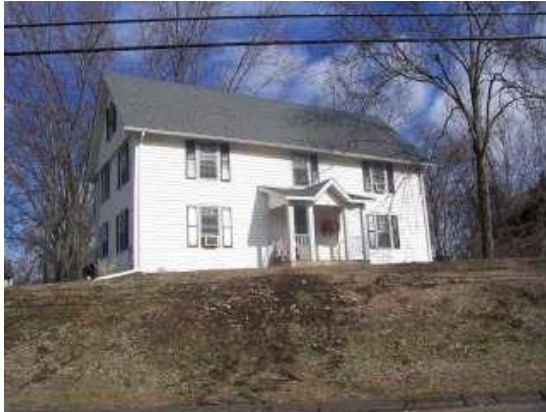
1934 WPA Census of Old Buildings in Connecticut Survey at the Connecticut State Library Digital Collection. Slide # 048

current owner: Mr. Keough & Joseph Zuk
Wood house, peak roof, brick chimney in front of ridge, two stories and a half, 5 window front, 1/1 sash, 3" overhang at gable at 3rd floor level, brick foundation now stuccoed.

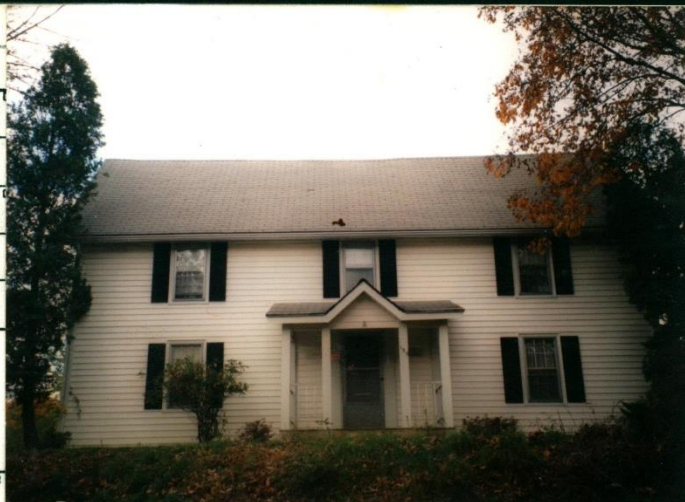
PHOTO	PHOTOGRAPHER HRC	
	VIEW NE	NEGATIVE ON FILE E18
COMPILED BY	NAME Historic Resource Consultants	
	FIRM The Colt Armory	
	ADDRESS 55 Van Dyke Avenue Hartford, Connecticut 06108

DESCRIPTION (Continued)	17 OTHER NOTABLE FEATURES OF BUILDING OR	
	<p>The Seth Stanley House has a three-bay facade with a central entry. The entry is protected by a gabled Victorian porch; porch detailing is obscured by modern siding. Windows are fitted with old 6-over-6 sash and modern storm sash. Second-floor facade windows are located immediately under the eaves. There is a hewn overhang across the rake ends; the sided cornice shows no return. There is a small recent chimney at the left rear. Two barns, one converted to a garage, and a wooden horse corral are located on the property to the left of the house.</p>	
SIGNIFICANCE	18 ARCHITECT	BUILDER
	<p>19 HISTORICAL OR ARCHITECTURAL IMPORTANCE</p> <p>Despite numerous alterations (including modern siding and a modern chimney), the Seth Stanley House is significant as a good example of an 18th century central chimney house. An adaptation of traditional English building techniques to a harsh climate rich in stone, timber, and firewood, the central chimney house was the predominant domestic building type in 18th-century New England. The large central chimney, generally constructed of stone below the roofline, functioned as an enormous thermal mass. Once warmed, its tons of rock could store and release heat for hours. It remained popular in relatively isolated areas such as Berlin until after 1800. Typical 18th-century features present in the Stanley House include the symmetrical three-bay facade, the hewn overhangs at the gable ends, the small-pane sash, and the location of the second-floor windows under the eaves.</p> <p style="text-align: right;">(continued)</p>

Seth Stanley is said to have built this house about 1750. Although the chronological succession is not absolute, three-bay facades became less common and five-bay facades more common in the later 18th century. The plan thus supports the relatively early date ascribed to the house.
